Excavations Northeast of the Theater

The excavations of the 2024 season (April through June) took place again in the southern half of the field northeast of the ancient theater (where the current field campaign began in 2018) and in the adjacent field to the west (Figure 1). Work concentrated on the area of the Marble Room, a very large room – perhaps an *apodyterium* – which was first discovered in 2020.

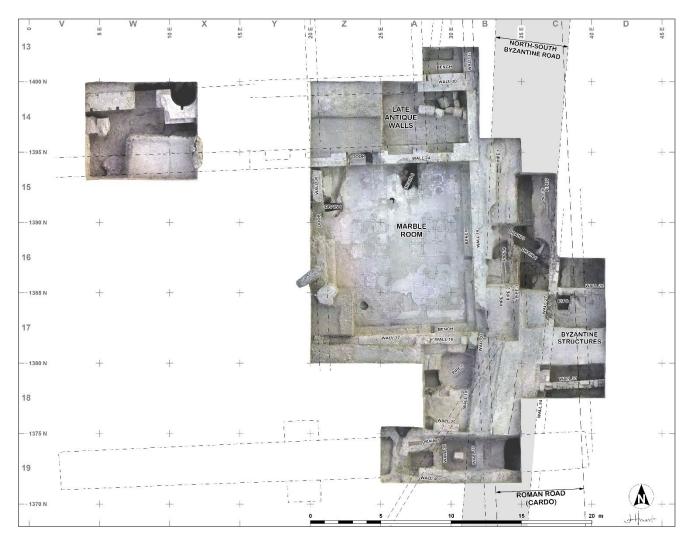
Figure 1. Northeast of the Theater area after the 2024 season (orthophoto J. Herbst)

To the west of the Marble Room, a test trench begun in 2023 was expanded to reveal more of a thick east-west brick-faced wall (wall 39) that must have separated two heated bathing rooms (Figure 1). This wall had been recorded by W. B. Dinsmoor in 1910, but the new excavations revealed some inaccuracies in his plan. The portion of the wall 39 revealed in 2024 includes a doorway, 1.56 m wide, and a semicircular niche, 1.90 m wide, located east of the doorway in the north face of the wall (Figure 7). A small portion of the floor of a hypocaust

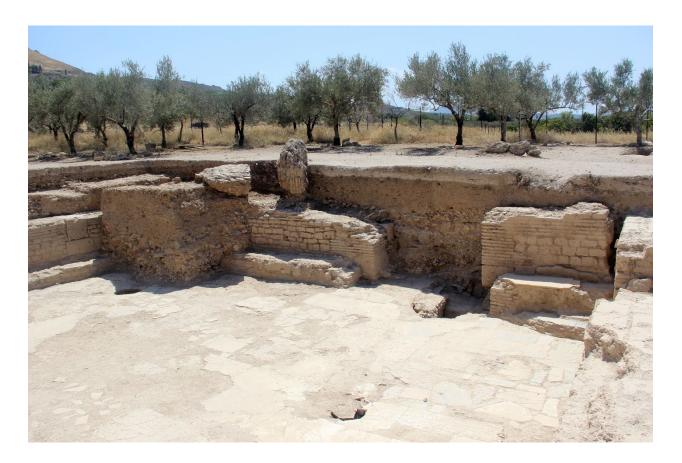
Additional portions of its west wall and large (2.36 m wide) west doorway were exposed, and additional areas of its *opus sectile* floor were unearthed (Figure 2). Some of the floor still

preserved its original design of circles within square frames, but much had been subject to a rather haphazard Late Antique repair that incorporated fragments of reused marble revetment.

Figure 2. West wall and doorway of the Marble Room

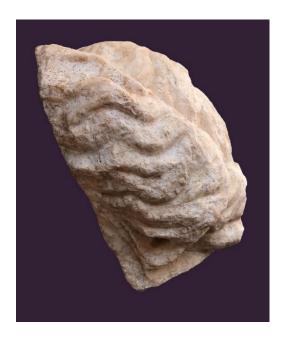
Figure 3. Sculpture fragments: under-life-size hand (left), life-size female head (right)

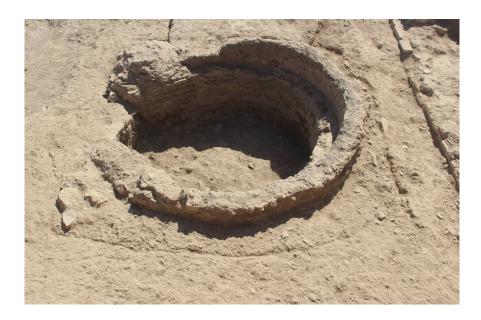
Remains of a lime kiln came to light unexpectedly in the southwest quadrant of the Marble Room (Figure 4). It was created within a circular pit cut into the Late Antique fill that covered the Marble Room. The inner surface of the kiln was coated with lime mortar, and the upper part of the kiln, rising above a narrow interior shelf, consisted of a thin pisé wall. The chamber of the kiln had evidently been cleaned out, leaving no clear evidence for its floor or for the quicklime (calcium oxide) that would have been produced within it; nonetheless, evidence of

burning within the sides of the kiln and a broad, dense scatter of marble fragments outside the apparent stoke hole at the north side of the kiln support the identification of the structure. The

Figure 4. Lime kiln above the Marble Room

fact that the kiln was dug into the preexisting Late Antique fill that covered the floor of the Marble Room confirms that the kiln could not have been created and used prior to the 7th century. Fill within the kiln, which must reflect the time of its abandonment, contained

predominantly Late Antique pottery, but a few Middle Byzantine sherds would seem to push the date to the 12th century. It is unlikely that the fragile structure would have survived long if it had not been filled in soon after its use; therefore, the construction and use of the kiln was more likely associated with the Middle Byzantine period than the end of antiquity.

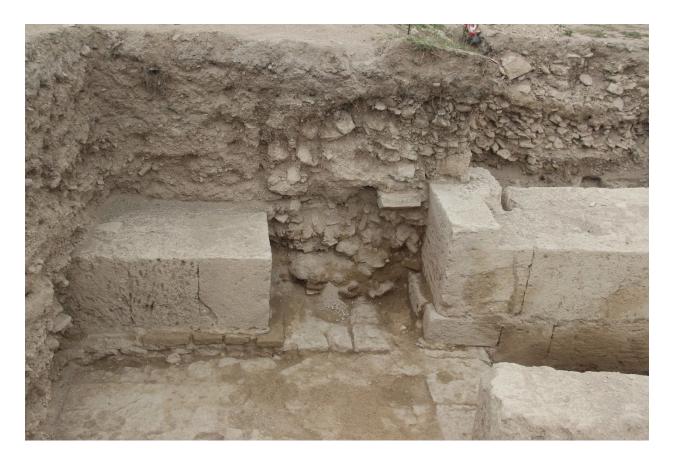
At the north end of the Marble Room, additional portions of two later (probably 6th-century) walls (walls 24 and 30) were uncovered. In the more northerly wall (wall 30), which was built with large poros ashlars, an apparent doorway was revealed opening onto the unexcavated area to the north (Figure 6). The nature of the building(s) to which these walls belong remains unknown, but the deep deposit of destruction debris (bricks, tiles, and crumbled mortar) that filled the space between the walls would seem to confirm that the building(s) suffered a violent destruction, most likely from an earthquake. The marked difference between this destruction deposit and the secondary dumped fill over the larger, southern portion of the Marble Room shows that the spaces to either side of wall 24 had strikingly different histories despite their proximity.

Figure 6. Wall 30 and doorway with overburden of destruction debris, view from south

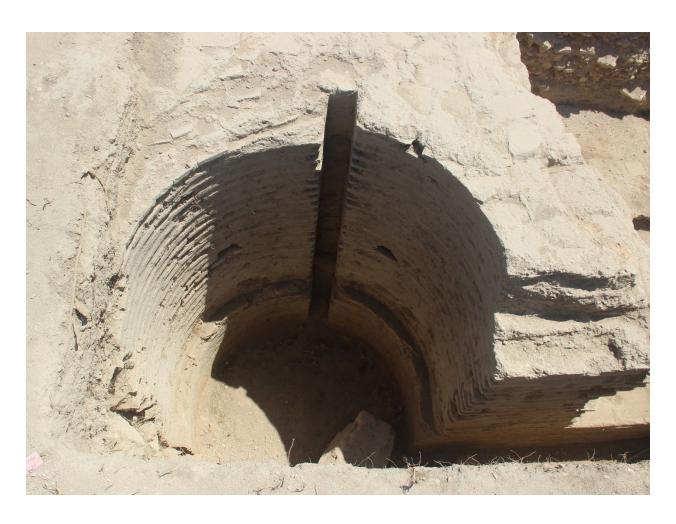
Figure 7. Niche in north face of Wall 39, view from north

was revealed to the north of the wall, but none of the elevated floor (*suspensura*) was preserved here. To the south of the wall 39, a few of the supporting pillars (*pilae*) of the original elevated floor were partially revealed, but, again, none of the elevated floor itself was found in situ. Deep fill on both sides of the wall consists of building debris (bricks and crumbled mortar) that seems to have been deposited where it fell with the collapse of the structure. As observed in 2023, a fallen mass of masonry, which appears to represent a rectangular pier, came to rest just south of wall 39. Further excavation in 2024 revealed that this fallen masonry pier rested on an accumulation of destruction debris above the level of the now missing elevated floor (Figure 8). Further excavation will be needed to fully clarify the stages in the demise of the structure, but it is now evident that the heated rooms to either side of wall 39 had already been abandoned and their floors removed before building debris from collapsing walls (and perhaps brick vaulting) filled the hypocausts. After the falling debris had accumulated to some considerable depth, the masonry pier collapsed, and additional building debris fell on top of the pier and buried the adjacent wall.

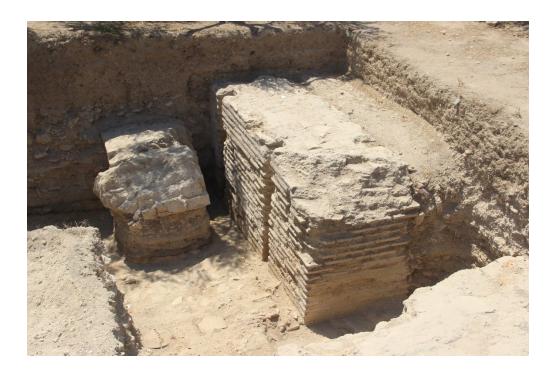
Figure 8. Wall 39 and fallen masonry pier, view from east

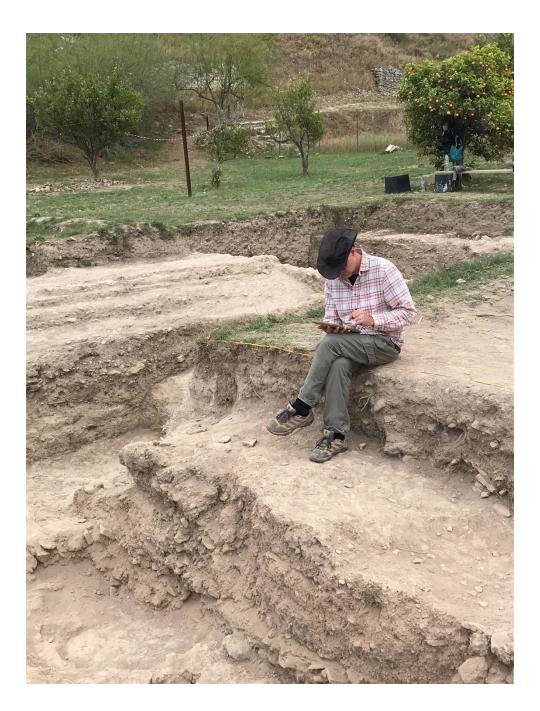
Sergio Alvarez taking notes on the lime kiln in iDig

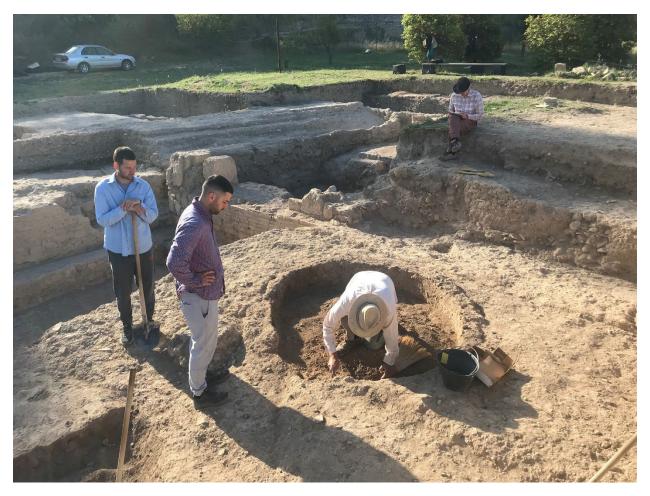
Thanasis Christou, Spyros Christou, and Panos Kakouros excavating within the lime kiln

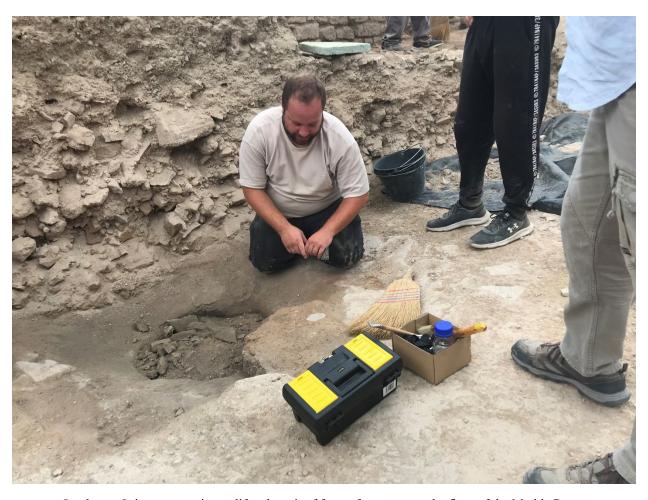
Stephanos Spiggos preparing to lift a deposit of fresco fragments on the floor of the Marble Room

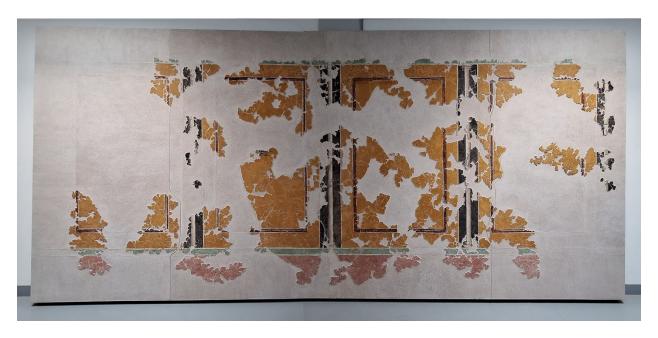
Throughout 2024, the work of conserving and restoring the wall paintings excavated in the 1980's in the area to the east of the Theater continued to be carried out by a team of conservators from the Centro di Conservazione Archeologica – Roma. One long wall, decorated with birds in yellow panels, was given its final surface treatment.

Wall with birds on yellow panels (photo Roberto Nardi)

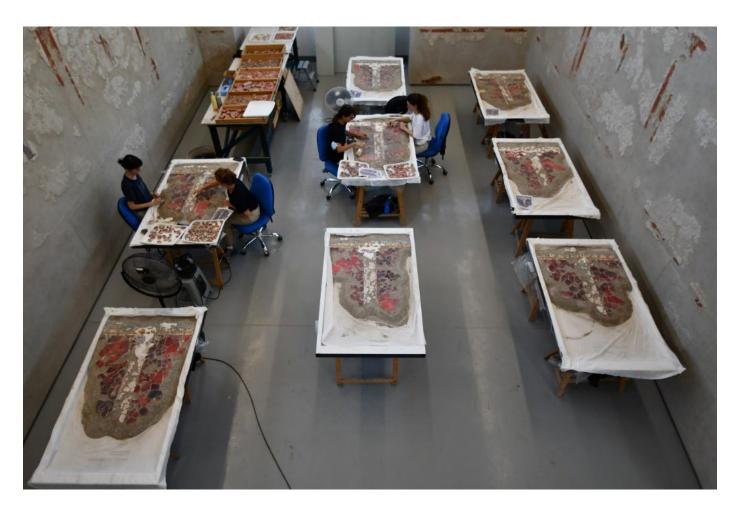
A series of panels probably belonging to the back wall of the ambulatory space around the top of the cavea of the theater, were assembled and prepared for mounting. This wall, conforming to the 2nd Pompeiian Style, presents a colonnade of Corinthian columns supporting an abbreviated entablature with an egg-and-dart crown. Portions of a wall or walls decorated with a frieze of racing chariots was also prepared for mounting.

Assembly of panels from of the Second Style wall probably from the top of the cavea of the theater (Photo Roberto Nardi)

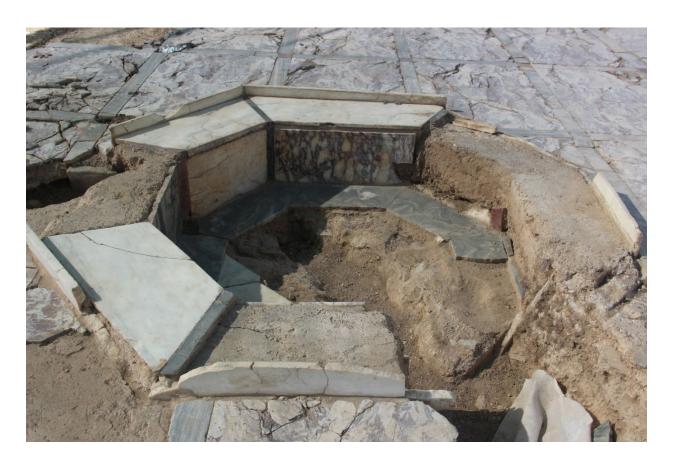
In the summer of 2023, cleaning and minor conservation work was carried out on an *opus sectile* floor of the fountain court of the Roman *domus* in the Panayia Field southeast of the Roman Forum.

Figure 12. Opus sectile floor and fountain of the domus of the Panayia Field after cleaning
